Divisional Manager  
South West M&R

# ADAS Conspicuity Results & Potential Improvements

# IPV Strike

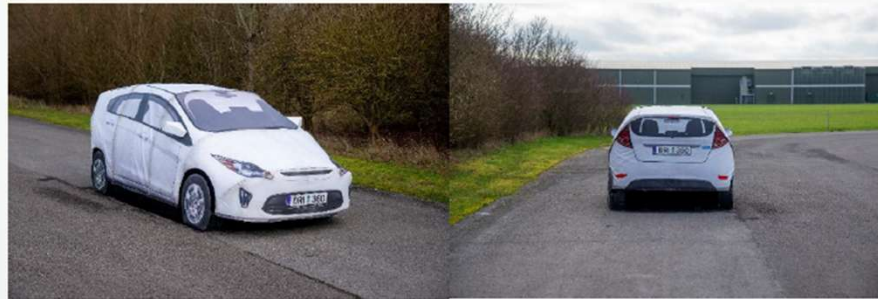
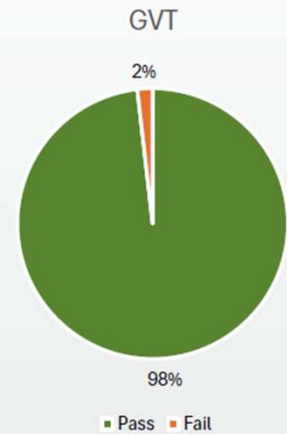
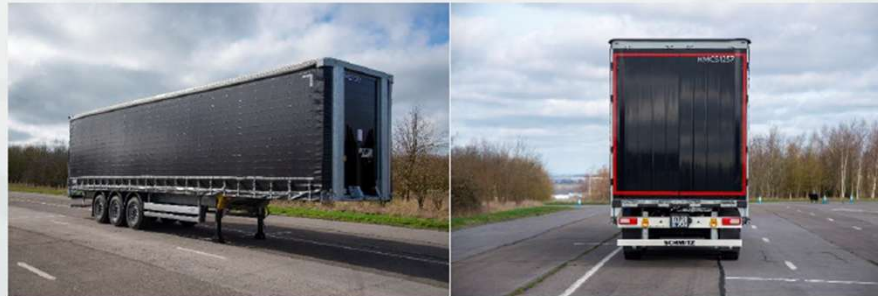
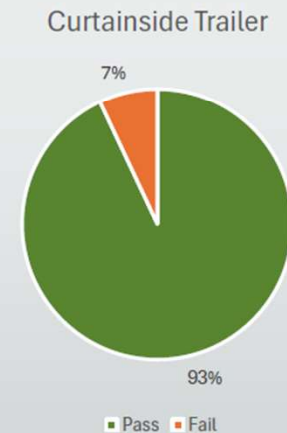
# Ringway: General finding baseline vehicles

- Note: two less passenger cars on Ringway day – from ‘good’ end of performance
- Baseline detection with vehicles used on Ringway day, slightly worse as a result

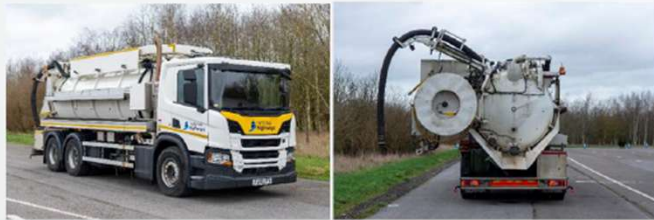
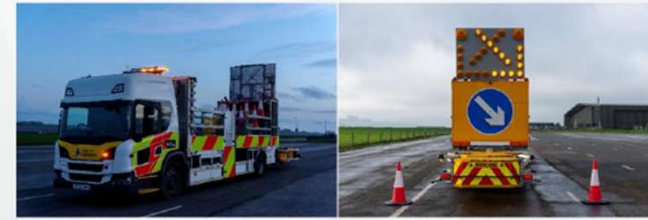
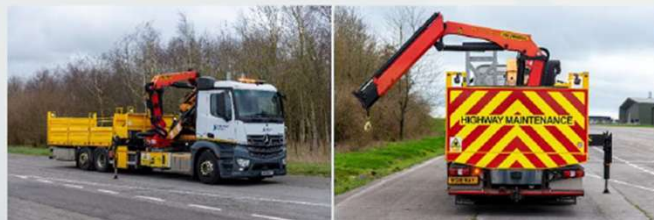
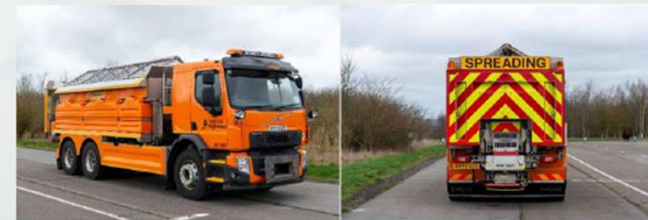
# Ringway: Stationary Target, Full Overlap

\*Car 3 not tested against gritter in this scenario, inclusion of estimated Car 3 results would give the same overall result +/- 1%

Impact Protection Vehicle

Barrier Rig

\*Car 1 not tested against gritter in this scenario, inclusion of estimated Car 1 results would increase pass rate to 83%

Gritter

- Ringway roadworks vehicles are detected often by ADAS, but significantly less than standard test targets, standard HGVs and passenger cars.
- The single HGV tested, saw a larger reduction compared to standard targets, than the typical passenger car, but the worst individual vehicle was a passenger car. HGV impacts carry a larger risk of injury to occupants of Ringway vehicles.
- Only one HGV was tested so this may not be representative of the full HGV fleet.

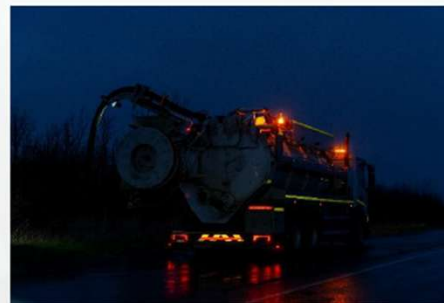
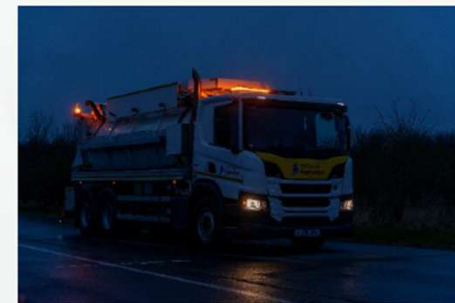
Vactor

# Darkness – Target vehicle lighting conditions

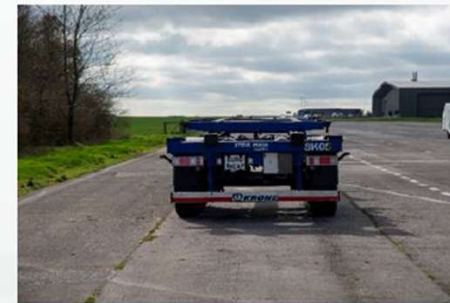
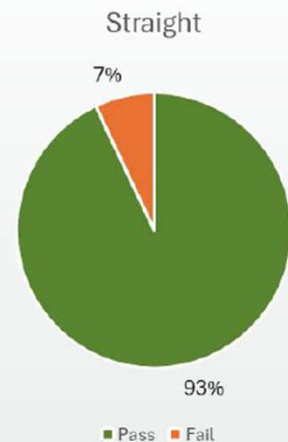
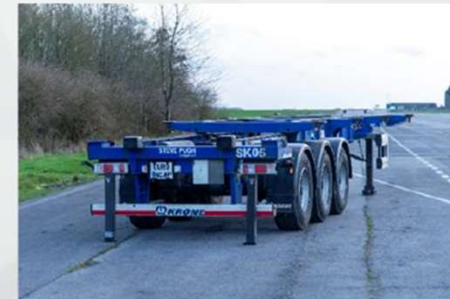
- No further research needed
  - Angled vehicles
  - Positions near changes in slope
  - Stationary vehicles
- All reduce probability of detection for at least some vehicles
- Roadworks may happen anywhere, often must be stationary, but if you can....
  - In daylight
  - Use moving vehicles, even 5 mph
  - Place vehicles in flat areas
  - Align with the road

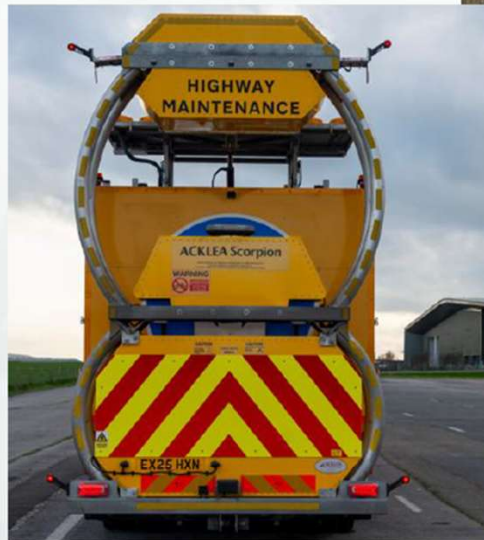
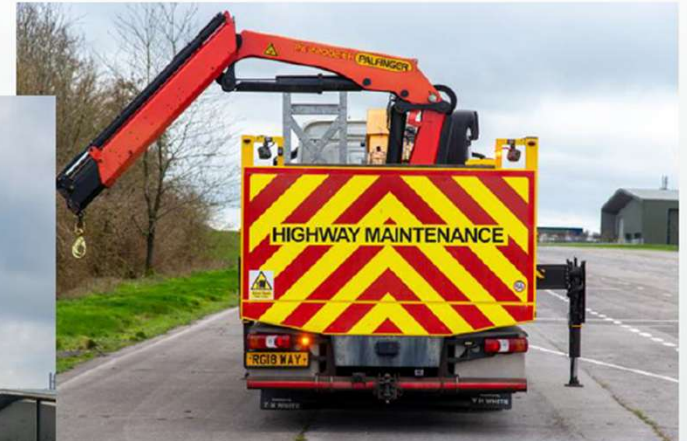
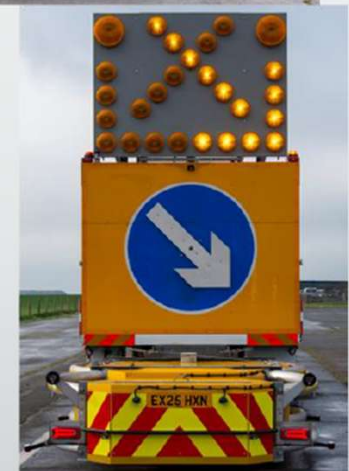
# Theory 1 – Conspicuity Markings

- What sort of thing affect how quickly a human can recognise an object:
  - Shape
  - Size
  - Clutter
  - Contrast
  - Colour & Detail
  - Expectation
- What do we do when we want something to be seen?
  - Retroreflective – contrast good
  - Colours clear
  - Shape, detail much less clear
  - Volvo truck feedback: IPV may be seen as gantry sign above road sign, no confidence, no activation

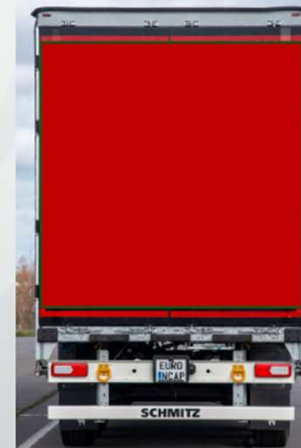
# Theory 1 – Conspicuity Markings

- What sort of things affect how quickly a human can recognise an object:
  - Shape
  - Size
  - Clutter
  - Contrast
  - Colour & Detail
  - Expectation
- What works?
  - Black semi-trailer well seen day & night
  - Shape is simple, rectangular, one whole above lights number plate etc
  - Black High contrast during day, poor at night
  - Simple retroreflective rectangle plus standard lights helps at night but not perfect
    - Higher night contrast help?

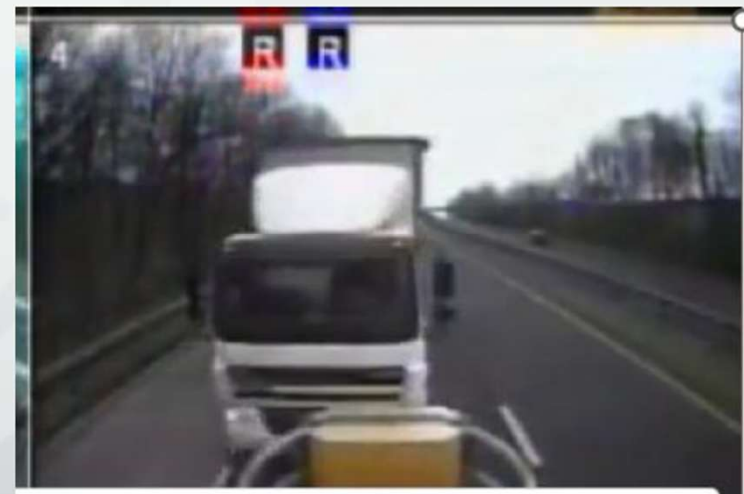
## Theory 2 – Attenuator face width

- Lateral overlap affects AEB response
  - Larger overlap = higher system confidence of collision, reduced opportunity to avoid, stronger intervention
- Below half vehicle overlap, AEB response diminishes
- ~3/4 of white truck overlaps IPV truck
- Only ~1/2 of white truck overlaps attenuator face, defined by lights and vertical edges
- Crash tubes etc. are unusual structure, unlikely to be recognised as part of vehicle width

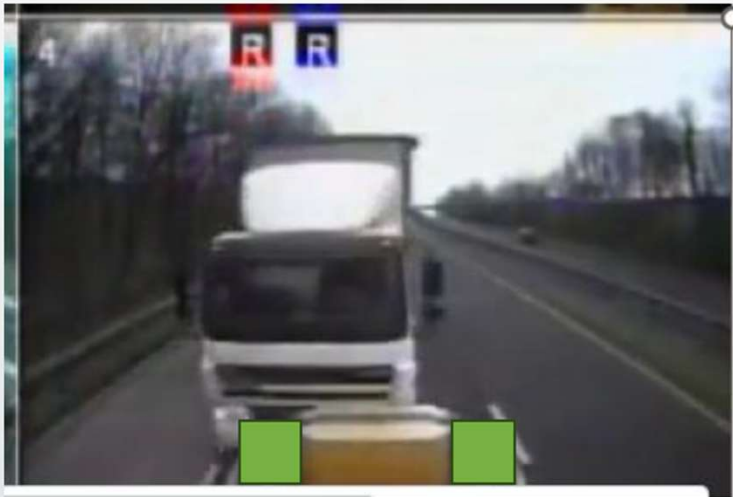
- If attenuator face was full HGV width, white truck overlap would be ~3/4, may promote AEB response

- But, inhibits ability for drivers to swerve around in last moment reactions and glance off structure—make it soft sacrificial, not structural

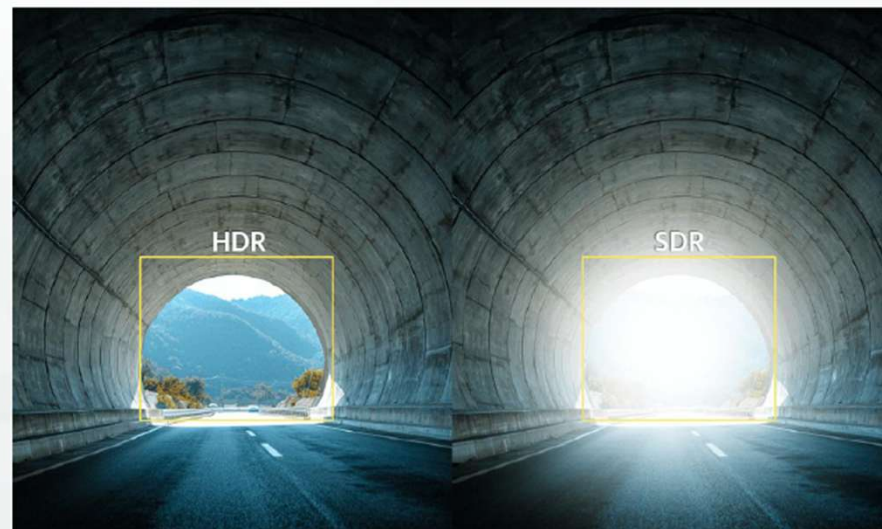
## Theory 3: Beacon brightness

- In darkness: dimly illuminated vehicle and surroundings, bright beacons as point light sources
- Camera dynamic range: range of light and dark tones captured in a single image
- High dynamic range required to capture details both bright and dark areas at the same time
- Reducing range between brightest light and dark areas supports image interpretation
- Volvo truck FCW response for Barrier Rig in darkness with beacons off, no response with beacons on (most other cars OK)

- Next step: How does beacon brightness affect ADAS and driver response?

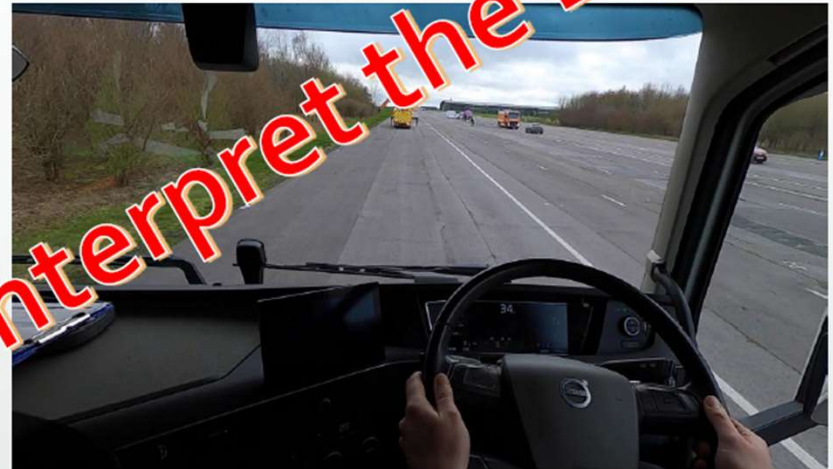
## ▪ Traffic Sign not Warning Beacon ✓

- No 360 deg requirement
- Flash rate appropriate
- Must be Amber

## ▪ Warning Beacons ✓

- Roof bar 360 degree
- Front repeater, not 360, not a warning beacon, must not flash

## ▪ Rear Flashers

- Not 360, not a warning beacon, must not flash, must show only red light to rear

- Even if flashers interpreted as warning beacons
- RVLR requires 1 to 4 Hz frequency
- Barrier rig flashers average c 10Hz and may not have "constant intervals"
- IPV is a traffic sign not beacon so doesn't need to comply, but mostly does anyway

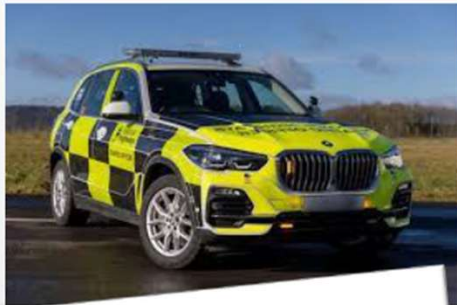
# National Highways Traffic Officer vehicles

- Front flashers, also illegal?
- No, National Highways have applied for a 'Vehicle Special Order' under Section 44 of the Road Traffic Act
- Exemption that specifically permits
  - Red flashers to rear
  - Flashing headlamps
  - Amber flashers to front or rear
- No control on frequency
  - Should there be, in light of results?
- Do Ringway have VSO's covering their vehicles?
